GRINDSTONE-LOST-MUDDY CREEK DAM C-3

DEKALB COUNTY, MISSOURI

**PHASE 1 INSPECTION REPORT
NATIONAL DAM SAFETY PROGRAM**

JUNE, 1980

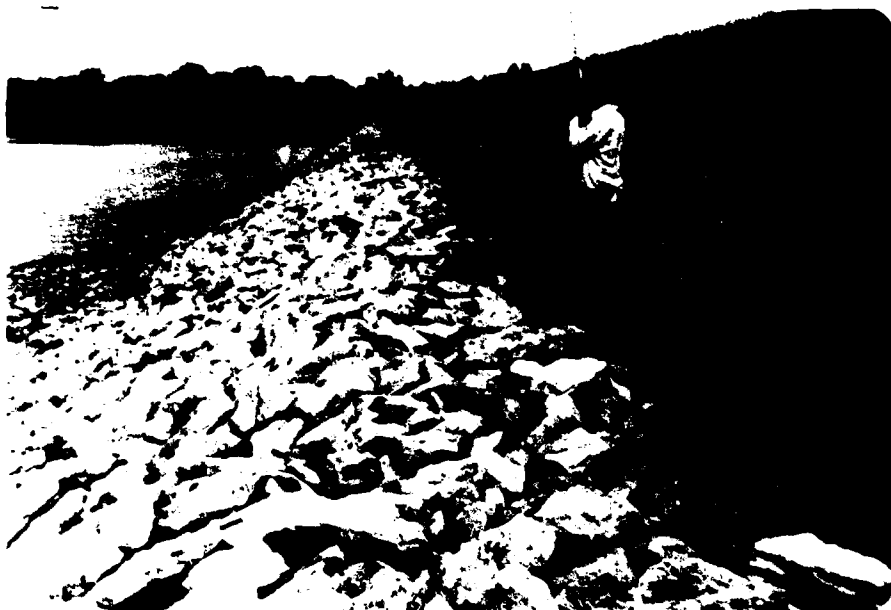
- (2) Upstream Slope. The upstream slope is well vegetated with adapted grasses from the crest down to the riprap. The riprap is durable limestone and looks good with no significant deterioration. A few small trees are growing along the waters edge in the left corner of the reservoir. Measurements indicate that the slope is somewhat flatter than shown on the plans. No slumps or deformations were observed on the slope. Photos 10, 11 and 12 show the upstream slope.

PHOTO NO. 12 - UPSTREAM FACE SHOWING RIPRAP AND ENTRANCE CHANNEL
OF EMERGENCY SPILLWAY IN BACKGROUND

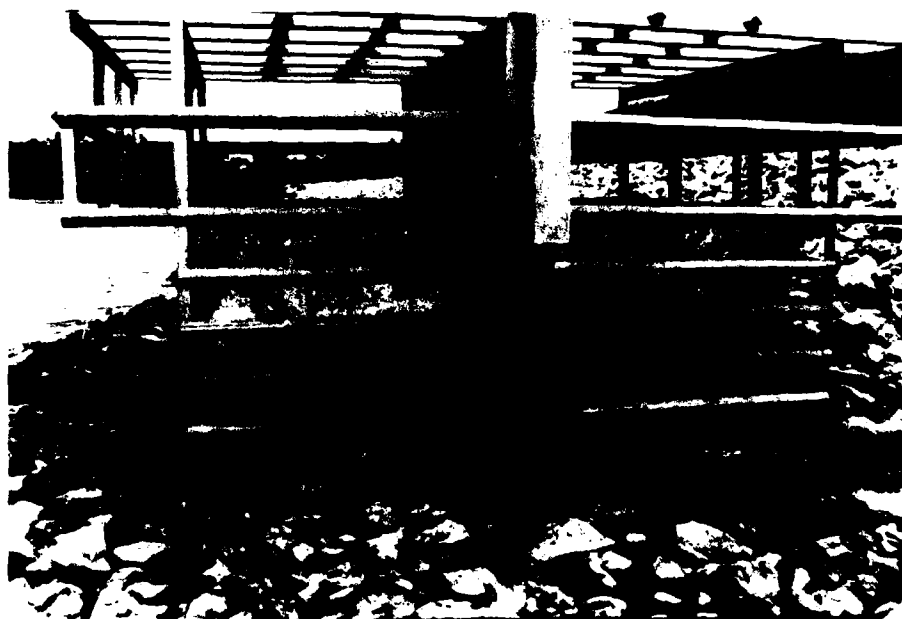
PHOTO NO. 15 - INTAKE STRUCTURE FOR PRINCIPAL SPILLWAY

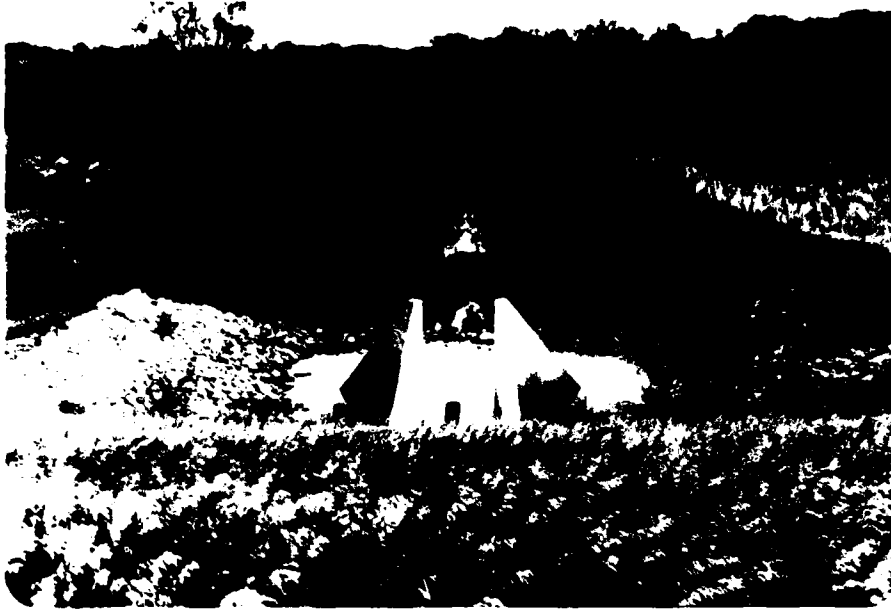
PHOTO NO. 16 - DOWNSTREAM CHANNEL AND OUTLET END OF PRINCIPAL SPILLWAY

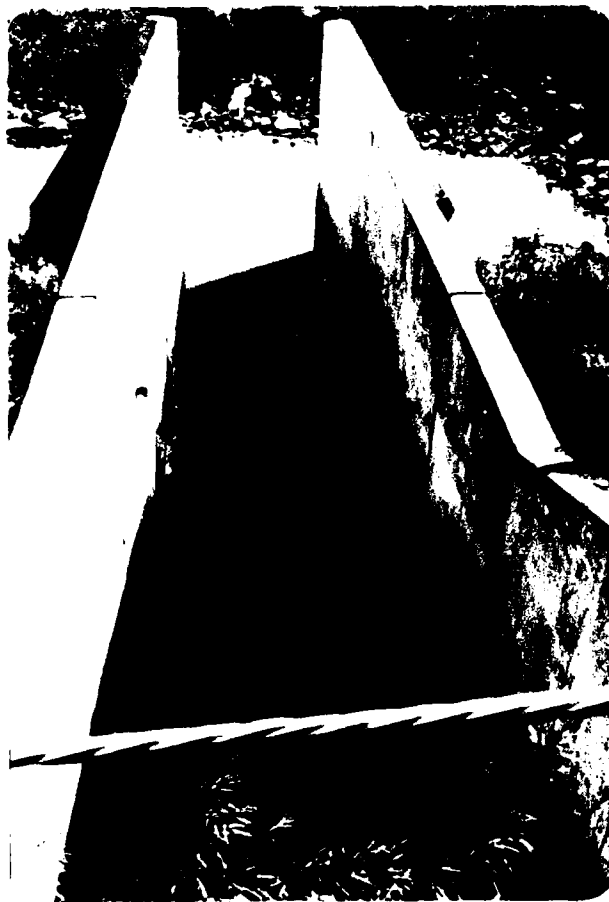
- (4) Downstream Slope. The downstream slope is well vegetated with adapted grasses. No cracks, slumps, or abnormal deformations were observed. No indications of seepage were observed on the slope or along the toe of the dam. The downstream slope is shown in Photos 4, 5, 6. The toe drain was not discharging at the time of inspection, but rust stains shown in Photo No. 17 indicate that the right drain has discharged in the past.

PHOTO NO. 17 - PRINCIPAL SPILLWAY OUTLET STRUCTURE. NOTE ENDS OF TOE DRAINS

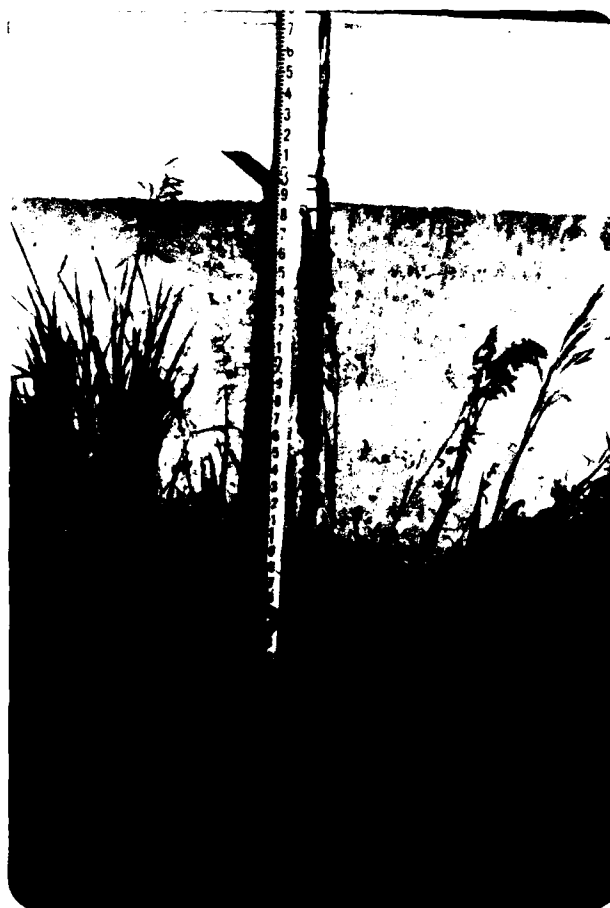
PHOTO NO. 19 - OPENING
OF JOINT IN SPILLWAY
STRUCTURE

The overall appearance of this dam after 10 years of operation is excellent. The maintenance program for the dam should include removal of the small trees which are growing along the waters edge at the juncture of the principal embankment with the secondary wing dike and also repair of the joint openings in the concrete spillway outlet.

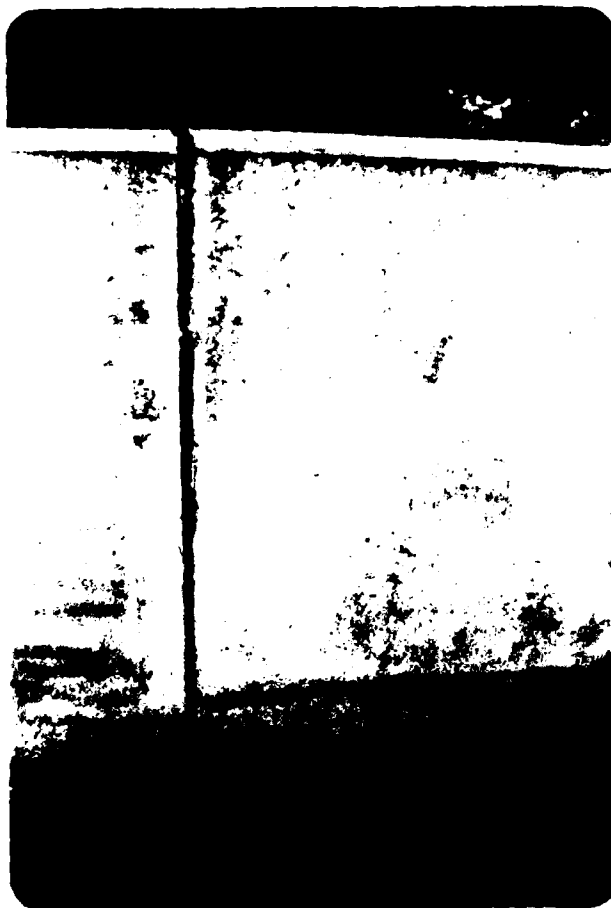
- (1) The Principal Spillway. The principal spillway consists of a reinforced concrete drop inlet (riser) with low level port; box conduit, and chute with energy dissipating blocks. The concrete in the inlet and outlet sections looks good with no signs of spalling or cracking. Inspection of the box conduit showed no cracks, spalling or abnormal elongation. The trash rack shows no sign of deterioration. Photos 14 and 15 show the inlet structure. Photos 16, 17 and 18 show the outlet structure. The second joint of the chute section (see E.J. 2 on sheet 4 of the plans) has opened up from the top downward on both sides of the chute wall. The opening on the right side is 1.3 inches at the top and tapers to zero down about 5 feet from the top. The opening on the left side is 1.3 inches at the top and about 0.4 inch down about 1 foot from the top. Photos 20 and 21 show the joint openings.

PHOTO NO. 21 - OPENING OF
JOINT IN LEFT SIDE OF
SPILLWAY STRUCTURE

- a. The emergency spillway size and/or the height of the dam should be increased to pass the Probable Maximum Flood without overtopping the dam.
- b. The joint openings in the concrete spillway outlet should be repaired.
- c. Tree growth on the upstream side slope should be removed and measures taken to prevent recurrence. Large trees or trees with an extensive system of roots should be removed under the guidance of an engineer experienced in the design and construction of dams.
- d. Periodic inspection of the dam should be continued with inspection reports made a part of the records of this structure.

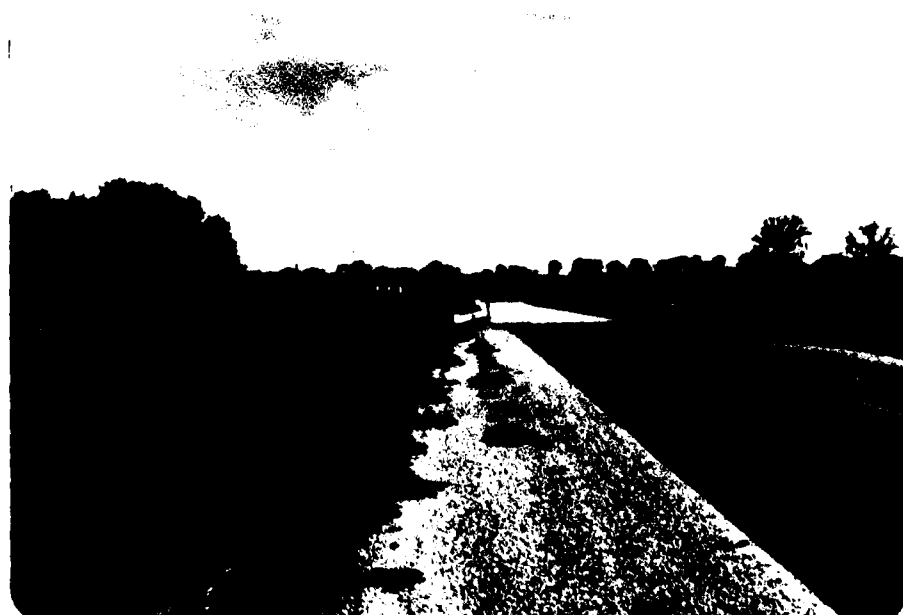
PHOTO NO. 25 - LOOKING SOUTH TOWARD LOST CREEK FLOOD PLAIN AT BRIDGE ON HIGHWAY A. ABOUT 8-9 MILES DOWNSTREAM
